# **FAILURE STUDY OF RUBBER-CORD FLEXIBLE COUPLINGS AND THEIR MOUNTING BOLTS**

Summary of the Doctoral Thesis

**RIGA TECHNICAL UNIVERSITY**

Institute of Transport

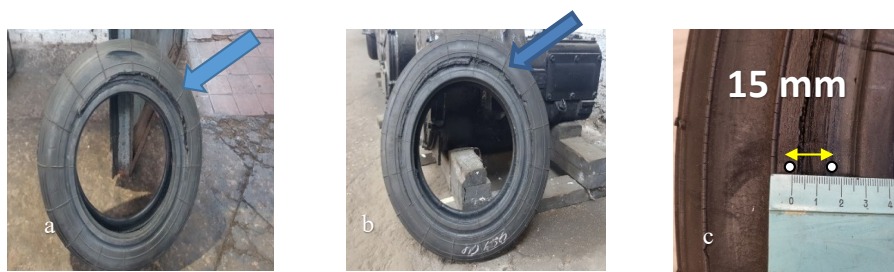
There were 21 cases of coupling damage in the period from September 2019 to 31 December 2021. Examples of the side surface disintegration of the rubber-cord coupling are shown in Fig. 3.1.

Fig. 3.1. Examples of the side surface disintegration of a rubber- cord coupling: a – sample 1; b – sample 2; c – determining the destruction zone sample 2.

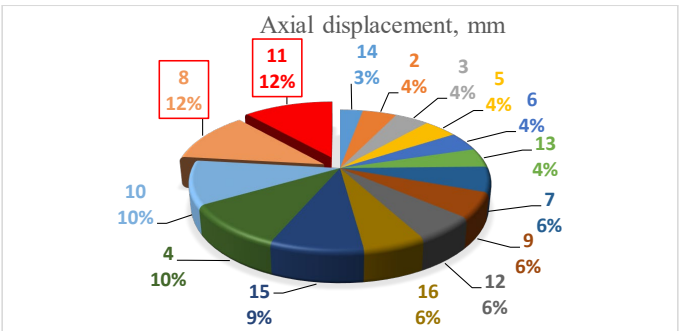
Fig. 3.3. Axial displacement of values in percentage.

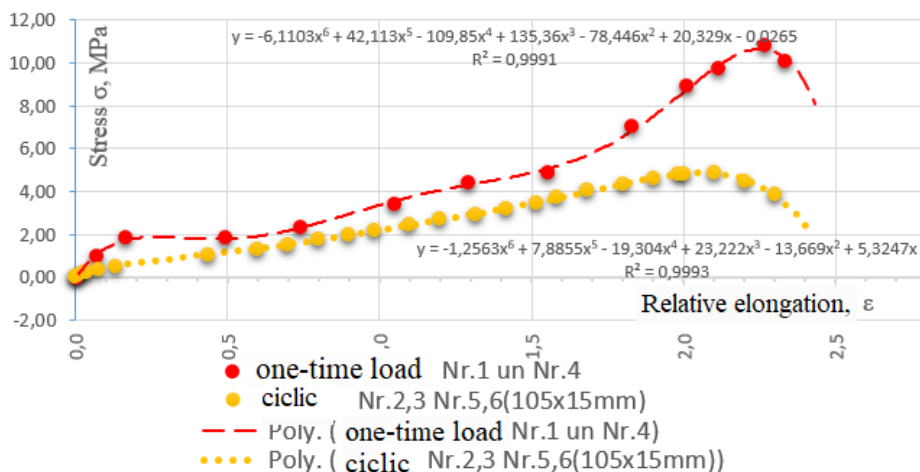
A comparison of the results of the one-way stretching test of coupling Fragments 1 and 4 at one-time stretching ( $R^2 = 0.9991$ ) and coupling Fragments 2 and 5 at operation and extreme cyclic loads ( $R^2 = 0.9995$ ) until disintegration are shown in Fig. 3.6.

Fig. 3.6. Comparison of unilateral tensile test results.

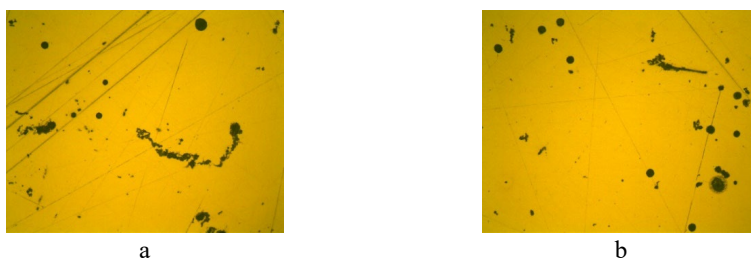
Metallographic analysis of bolts subjected to impact loads of 20 000 N and 100 000 N is shown in Figs. 3.32 and 3.33.

Fig. 3.32. Metallographic analysis after 360 impacts with a force of 20 000 N, magnification –  $\times 200$ :

a – Sample 15; b – Sample 16.
