## ENERGY PERFORMANCE OF RENOVATED SOVIET TIME APARTMENT BUILDING

**Gatis Žogla**, *assistant in scientific work, M.Sc.*  
Riga Technical University  
Institute of Energy Systems and Environment  
Address: Kronvalda bulv. 1, LV-1010, Riga, Latvia  
Phone: +371 26324712  
e-mail: [gatis.zogla@rtu.lv](mailto:gatis.zogla@rtu.lv)

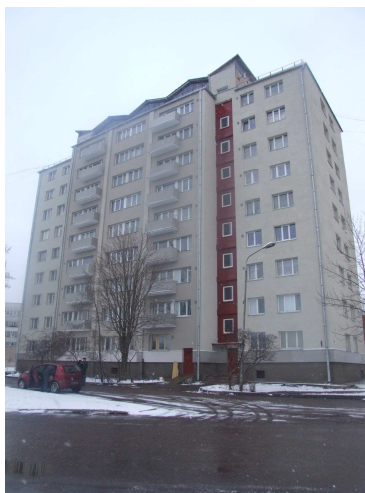
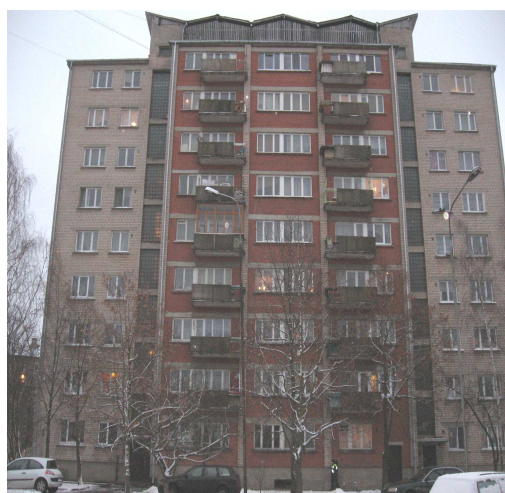
Figure 1. The studied building (a) and building with which it was compared (b)

Fig. 1 shows the studied building and one of buildings with which the studied building was compared.

Studied building, which is located in Daugavpils, Vienibas street 38a, was energy audited and afterwards renovated in the summer and autumn of year 2007. Following energy efficiency measures were done:

- Insulating of all outer walls (10cm polystyrene),
- Insulating of cellar roof (8cm rock wool),
- Insulating of roof (12cm rock wool),
- Replacement of staircase windows with insulation panels and plastic windows,
- Renovation of buildings heat substation.

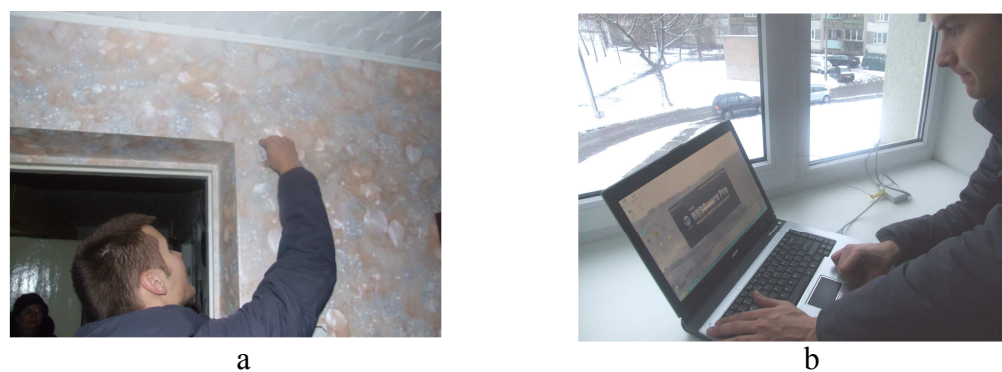
Figure 3. Placing of temperature loggers (a) and data retrieving (b)

Since the amount of used heat energy for space heating depends from outdoor and indoor temperatures, these temperatures were measured for period of three months in heating season – from January 23<sup>rd</sup> till April 22<sup>nd</sup>. In total 9 temperature loggers were placed in such manner that 2 outdoor temperatures, 2 cellar temperatures and 6 indoor temperatures were measured (one of temperature loggers was registering two temperatures). Operations with temperature loggers can be seen in Fig. 3.

HOBO data loggers were used. These loggers were programmed in such way that they registered temperature with 30 minute intervals. Temperature loggers were put only in the renovated building, indoor temperatures of the two not-renovated buildings, which were used to compare energy efficiencies in renovated and not-renovated one type buildings, were measured by hand-held digital thermometer during a visit to these buildings.
