**WORKING EFFICIENCY OF „SACRIFICIAL” PLASTERS –
PRACTICAL EXPERIENCE IN LATVIA****SANĒJOŠO APMETUMU DARBĪBAS EFEKTIVITĀTE –
IEGŪTĀ PIEREDZE LATVIJĀ**

Keywords: *monuments, stone materials, sacrificial plasters, soluble salts, restoration*

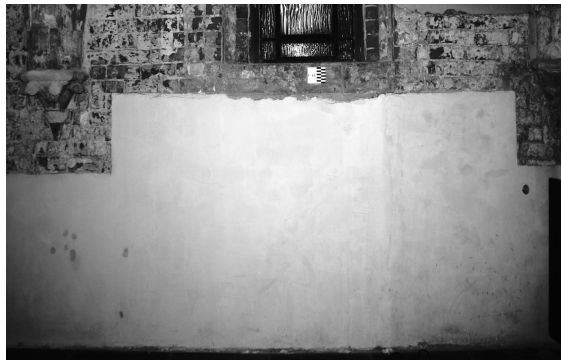
Fig. 12: Square of “sacrificial” plaster in Capithulum hall

Parallel above mentioned another experimental sampling site was examined in the Capithulum hall of Riga Cathedral. “Sacrificial” plaster No6 was applied on the surface of the 13th century brick wall (Fig.12) in 1995. Two boreholes were made in experimental sampling site in Capithulum hall in 2006. Anion and cation chemical analysis of borehole samples presented low concentration of salts in the depth until 8 cm of brick walls. The layer of “sacrificial” plaster was 0.6 cm thick. Gained results (Fig.9) presented that sample of “sacrificial” plaster (Fig.10) has low concentration of salts. That means that together with aforesaid this “sacrificial” plaster does not work. Salts accumulate right behind “sacrificial” plaster, but not in its pores as required.

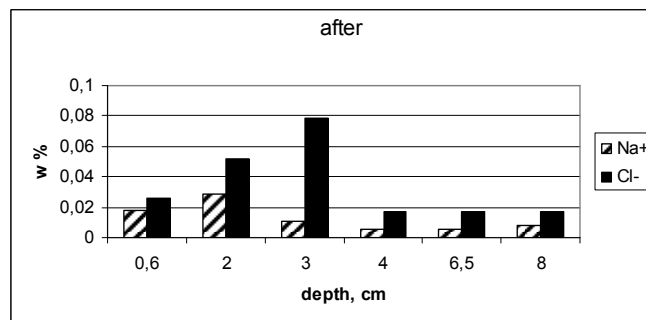
Fig.13: Content of soluble salts after application of “sacrificial” plaster No 6

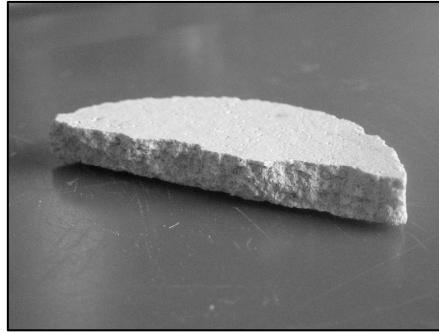
Fig.14: Sample of “sacrificial” plaster (0.6 cm thick)
