Description of the experiment: Damage detection of panel-to-panel moment joints in timber structures by Coaxial Correlation Method

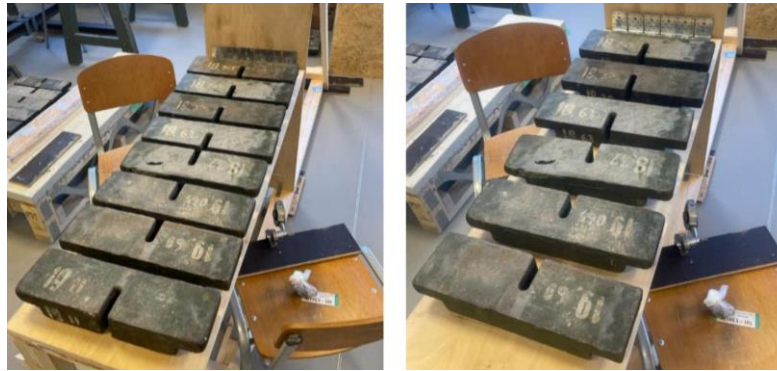
For both cases T1 and T2 (Figure 2) and for each of the ten joint states (Figure 3), measurements were taken for two static load levels equal to 113.9 kg and 151.8 kg. The loading was carried out by adding steel pieces with the

weight changing within limits from 17 kg to 21 kg. The placement of the steel pieces during loading is shown in Figure 4.

Figure 4. The placement of the steel pieces during loading with 8 pieces (left) corresponding to 151.8 kg, and with 6 pieces (right) corresponding to 113.9 kg.
