RIGA TECHNICAL UNIVERSITY
Faculty of Mechanical Engineering, Transport and Aeronautics
Institute of Transport

**ANALYSIS OF THE IMPACT OF RAIL
GRINDING ON THEIR CONDITION**

Summary of the Doctoral Thesis

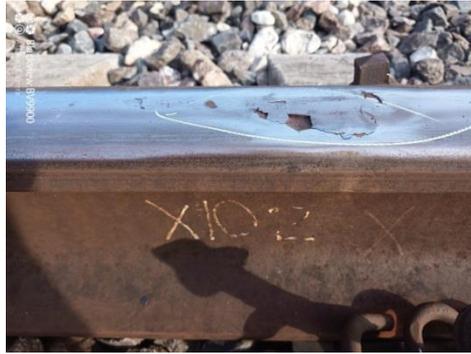
Fig. 2.2. A defect found in rail road section Menta–Daudzeva 256 km 6 pk.

Pitting of metal and delamination cracks on the running surface with code X 10.1-2 usually occur due to violation of rail production technology (closed rolling, small cracks, peeling, etc.) [2]. Such defects can be easily seen in visual inspection, see Fig. 2.2.

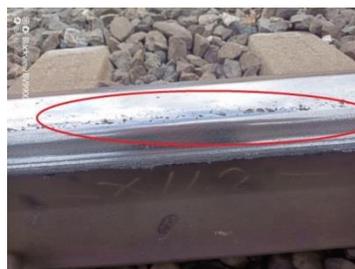
Fig. 2.3. A defect found in curve $R = 708$ m in Vecumnieki station 1, on the main road.

Flaws in metallurgical quality of rail steel (accumulation of local non-metallic inclusions, stretched along the direction of rolling) determine the insufficient contact fatigue strength. Most often the work edge of outer threads in rail road curve stations ($R = 400\text{--}1000$ m) are damaged, see Fig. 2.3. Pitting begins with the formation of inner longitudinal cracks of contact fatigue and development in the work cut-out zone of the real head. Contact fatigue cracks can also develop from rolling stock on the middle part of the rail head, gradually reaching under the rolling stock and creating elongated horizontal contact fatigue cracks. Usually, the defect is created on the outer rail work edge in the form of cut-out curves with a small radius, it can be accompanied by side wear. In some cases, a longitudinal crack can appear due to shallow upper contact fatigue cracks that are parallel and can develop even deeper [23].

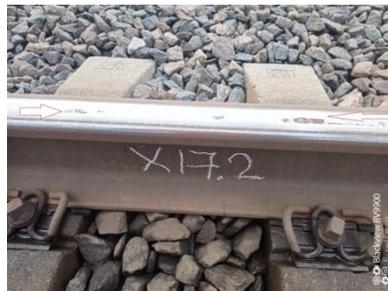
Fig. 2.4. Pitting on rail head surface in Vecumnieki station.

If the technology of rail hardening is not followed properly, zones of martensite or zones of local uneven hardness transition from the hardened to the unhardened metal layer can form in the hardened layer. During operation, metal delamination and pitting can occur in these zones due to the effect of the rolling stock, see Fig. 2.4. The acceleration of the defect appearance is stimulated by the curvature of the rail ends.

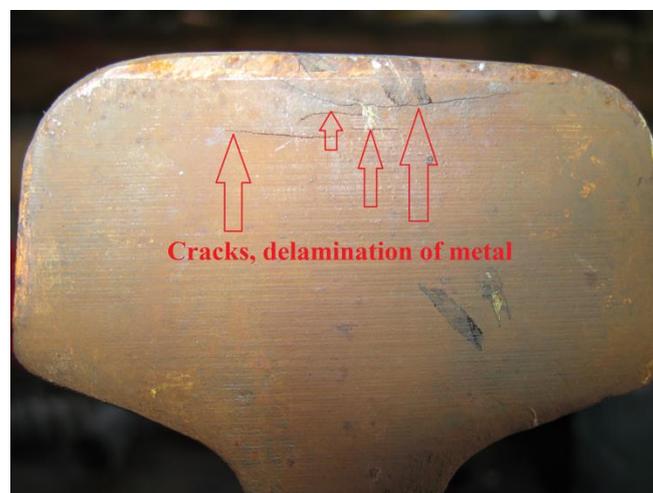
Fig. 3.5. Defect with code X10.1 found in railroad section Vecumnieki–Lāčplēsis.

One of the most popular defects in “Latvijas dzelzceļš” network is the defect with code X 10.1-2. This defect includes metal cracks and pitting on the running surface of head due to non-compliance with the manufacturing technology (closed rolling, small cracks, peeling, etc.) [2], see Fig. 3.5. The defect location designation with a number (third number in the defect code) is assumed as follows:

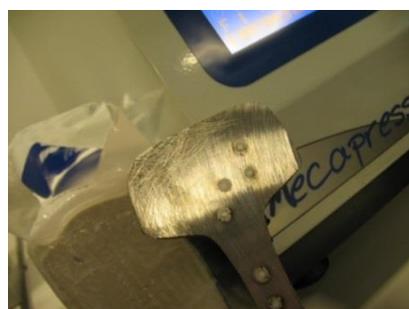
Fig. 3.8. Determination of chemical composition using chemical analyser PMI-Master PRO.

Further, using chemical analyser PMI-Master PRO, see Fig. 3.8, a full chemical composition for steel rail R350HT was found [7]. The results of the chemical composition are presented in Table 3.3.

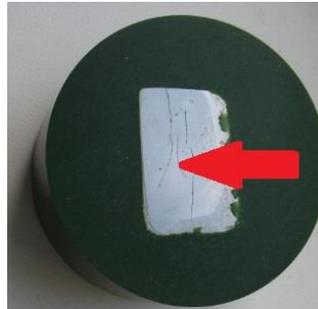
Fig. 3.9. Template of the damaged rail head after grinding.

Then, after pressing of the finished template, the template grinding and polishing was performed using Mecatech 334 system's grinding and polishing machine with water cooling, see Fig. 3.9.
