ULTRASONIC INSPECTION OF DAMAGE IN IMPACTED COMPOSITE PANELS

S. Ručevskis

In this study, a pulse-echo ultrasonic imaging technique is used to produce high-resolution images of internal defects arising as a result of low-velocity impacts on composite laminates.

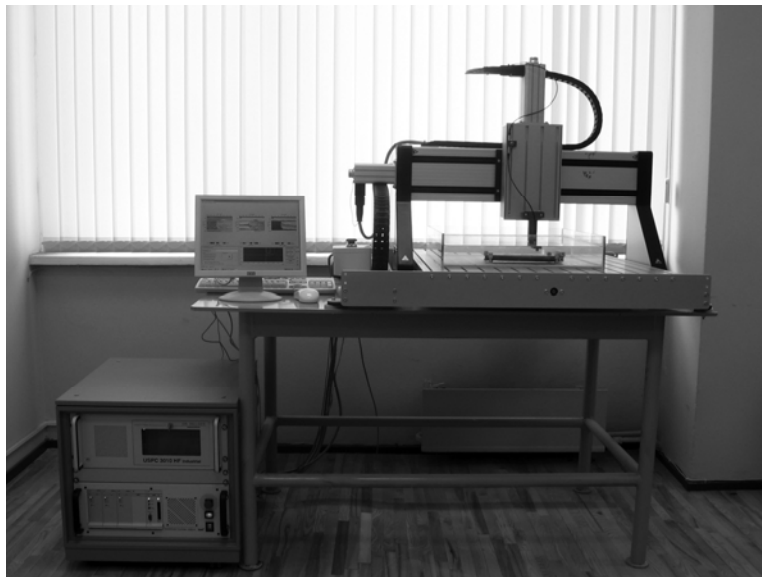
Fig. 4. Experimental set-up

An experimental set-up (see Fig. 4) considered in this study consists of a computer-controlled ultrasonic flaw detector USPC 3010 Industrial, an immersion probe of 10 MHz, a glass water tank, and a stepper motor-controlled XYZ-manipulator.

An industrial PC with *Hilgus* software provides manipulation and settings of the ultrasonic flaw detector, the storage of data, and imaging of test results in A-, B-, C-, and D-scans. The scanning system measures up to 20000 amplitudes and up to 10000 time-of-flight values per second.
